Mini Smile Makeover – Young Maestro Competition

Candidate: Balraj Singh Sohal BDS (Hons)

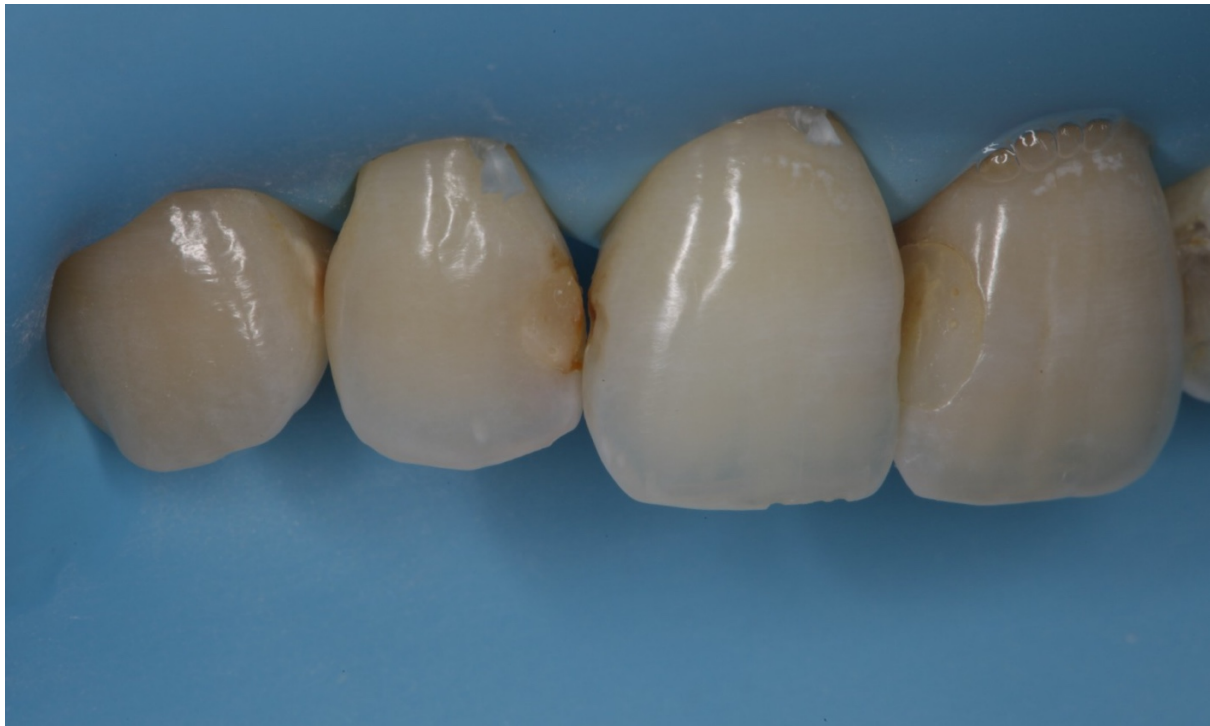
Figure 1 – pre-operative photograph, rubber dam isolation with floss ligatures to ensure optimum moisture control.

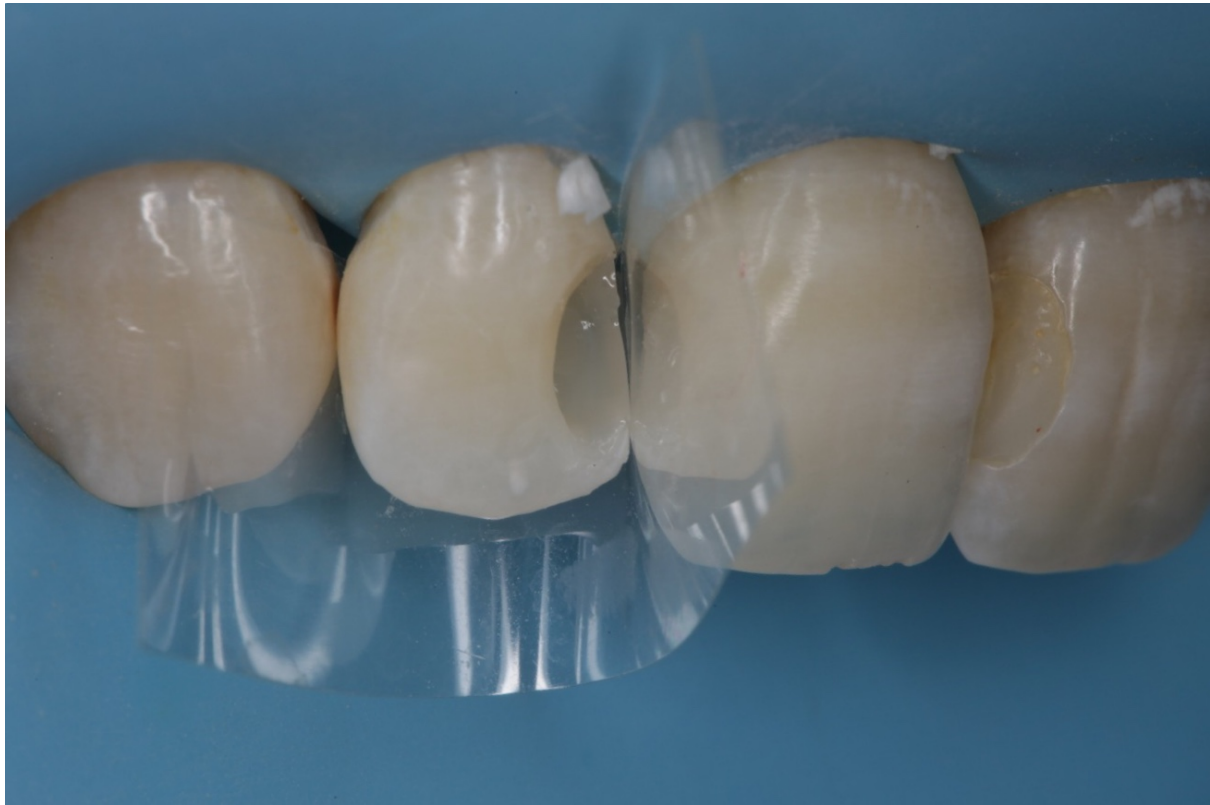
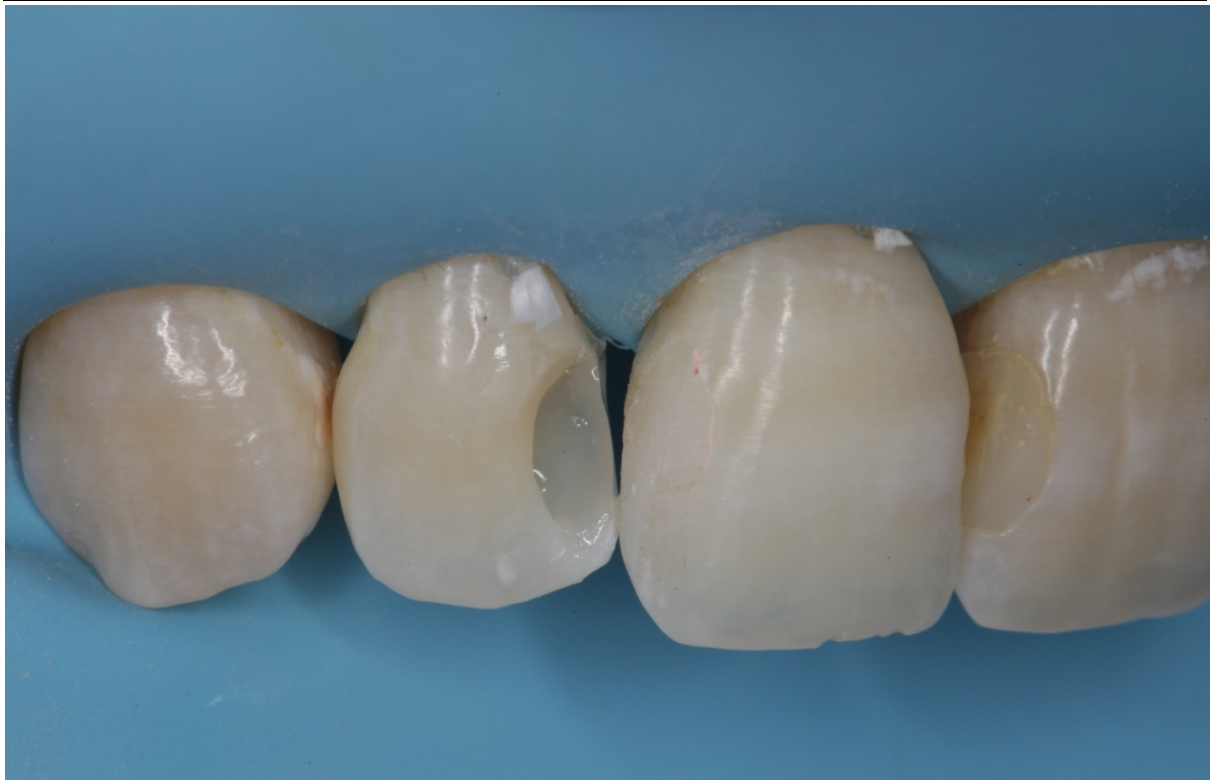
Figure 4 and Figure 5 – the UR1 was built first as it was easier to access and restore. Once the UR1 was restored a mylar strip was placed with consistent finger pressure from the palatal aspect to build the palatal wall of the UR2. After the palatal wall was built a Tor VM sectional matrix was used to build the mesial wall.

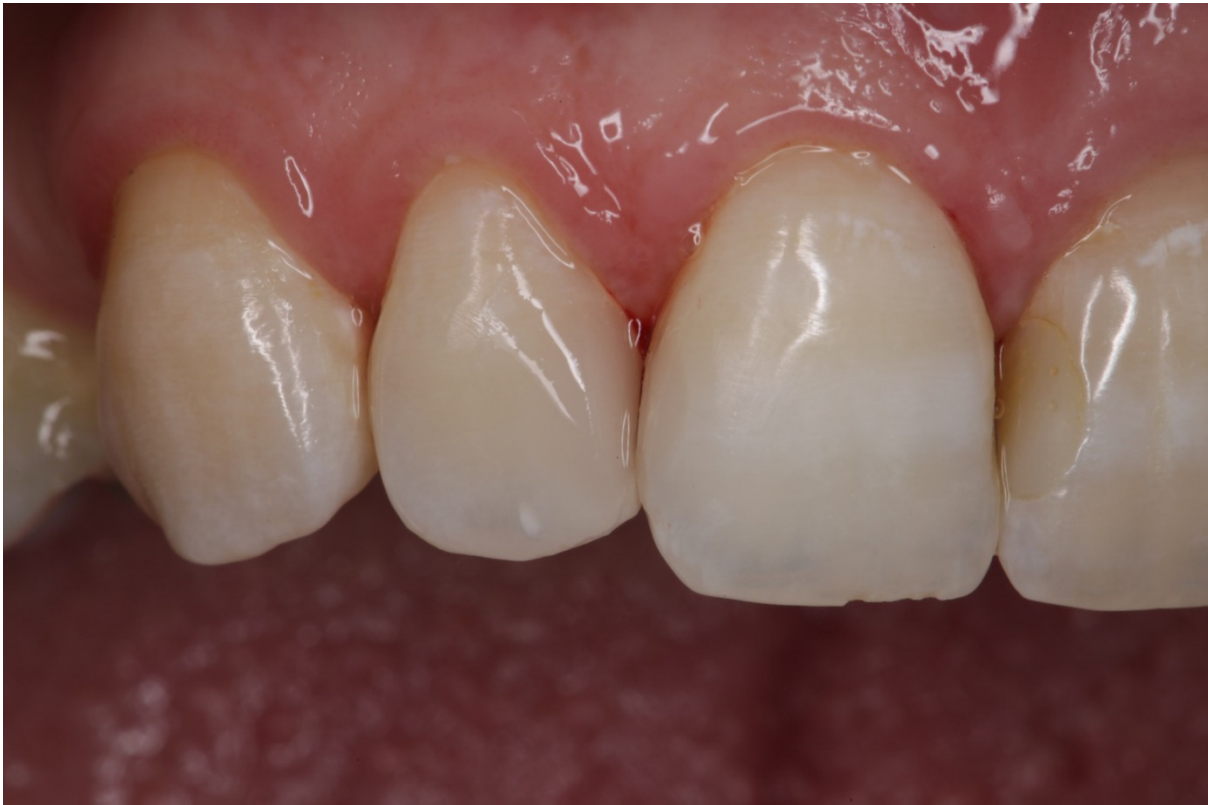
Figure 6 – Immediate post-operative view, gross finishing and polishing was completed – for this case only soft flex discs were used. The patient was to return a week later for final polishing although unfortunately failed to attend.

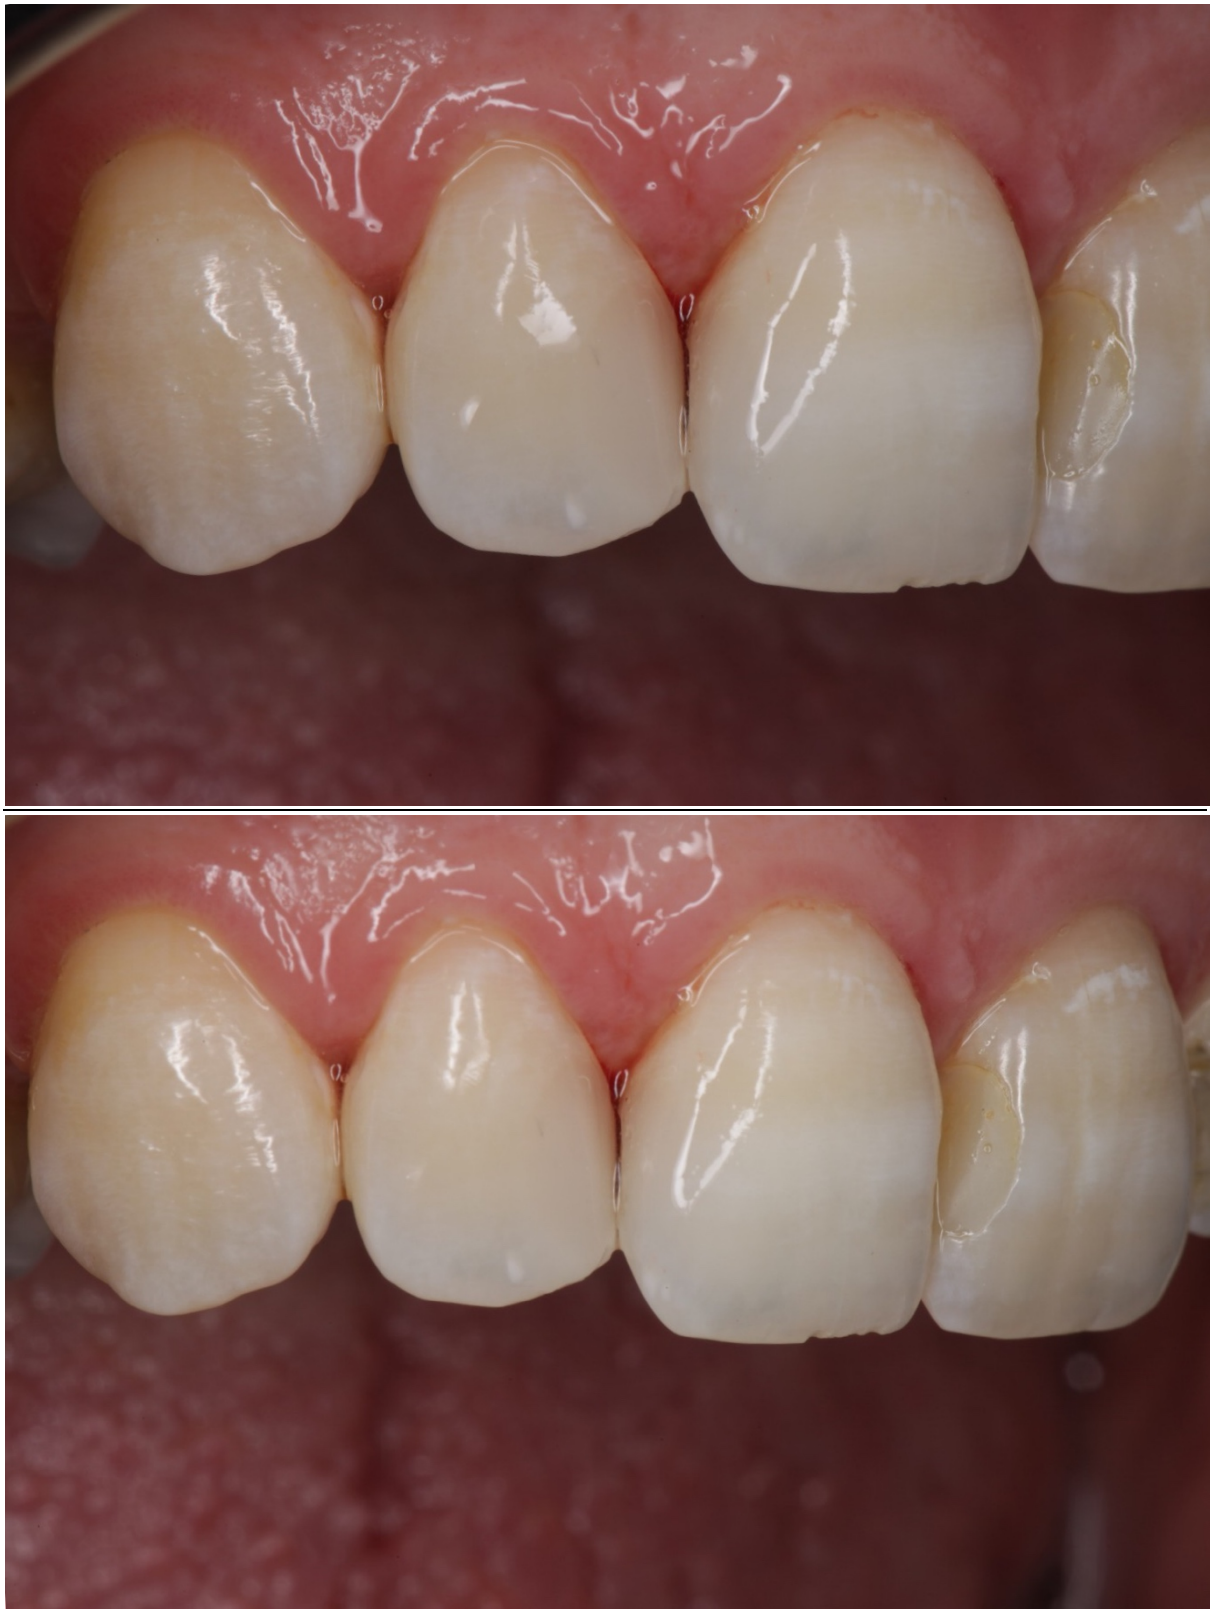
Figure 7 and Figure 8 – different views to showcase the effect of different angles of light on the restorations. The teeth of course look dehydrated as these photos were taken immediately after removing the rubber dam.

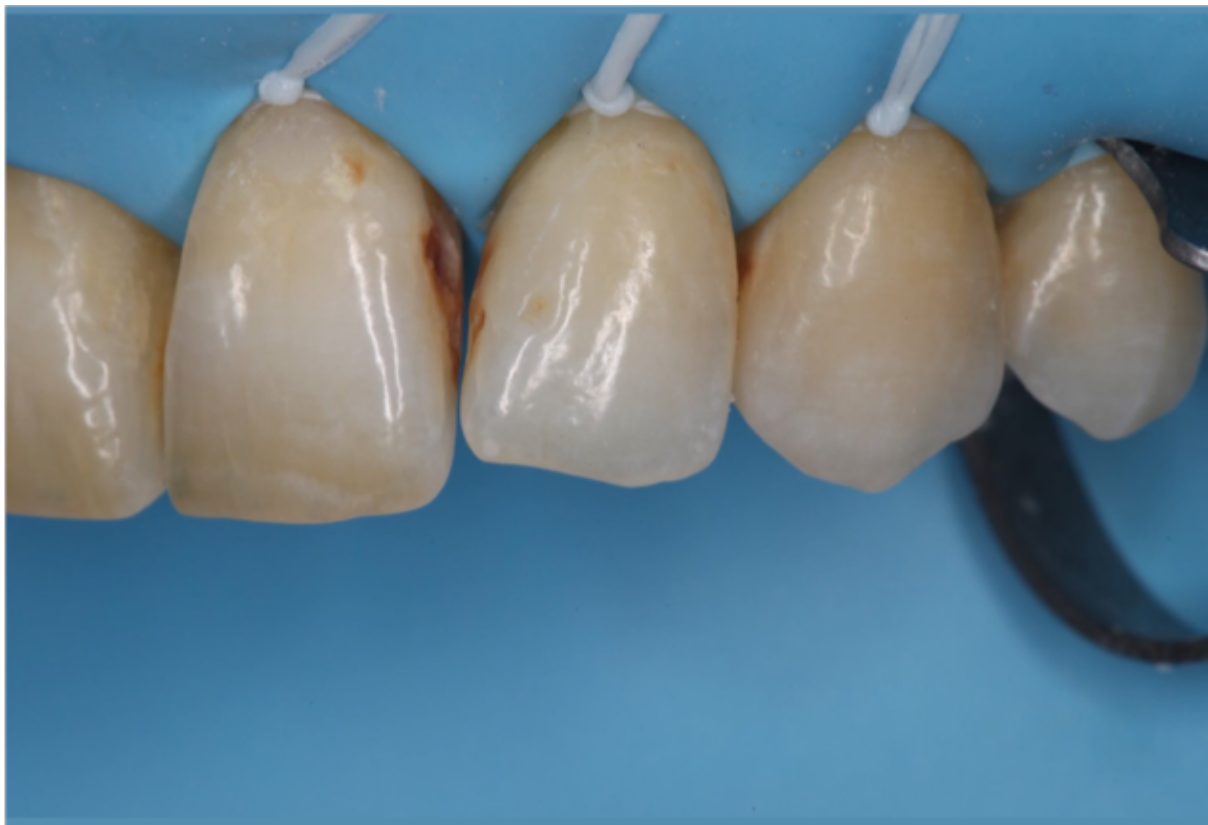
Figure 1 – pre-operative photograph, rubber dam isolation with floss ligatures to ensure optimum moisture control.

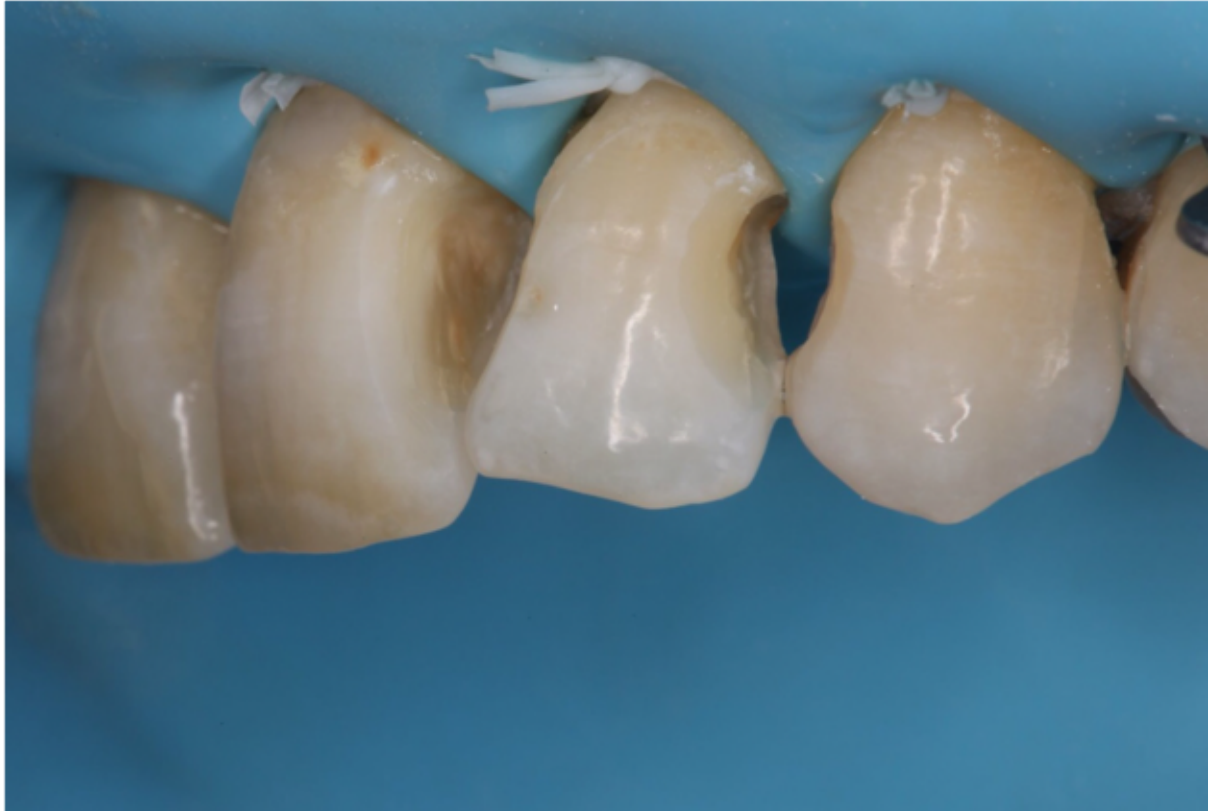
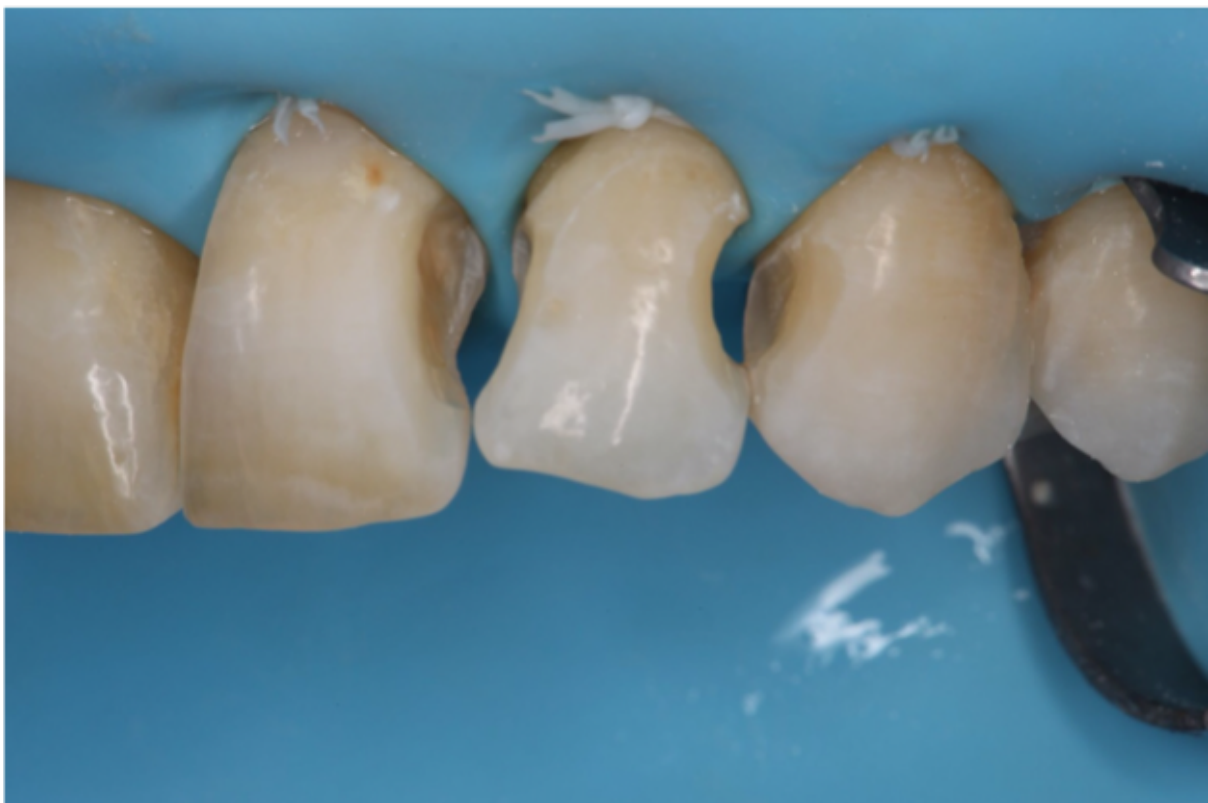
Figures 2 & 3 – caries removed, cavities prepared, margins bevelled and air-abrasion to allow a clean substrate ready for bonding. Note the UL3 distal cavity – the UL3 buccal enamel was preserved, as the caries was accessed palatally to ensure we preserved as much tooth structure as possible.

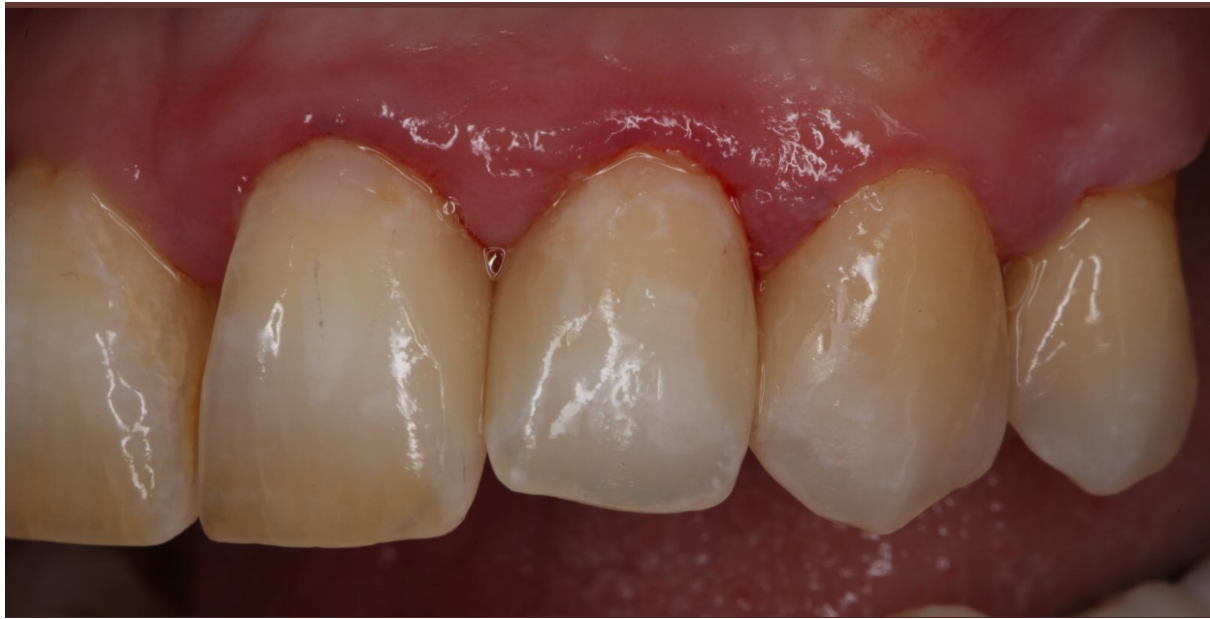
Figure 5 – The rubber dam was removed; minor adjustment was made to palatal aspect of the restorations to ensure they were comfortable in static and dynamic occlusion and to ensure they felt smooth to the patient's tongue. Note the inflammation of the gingiva due to the tight floss ligatures, this will subside.

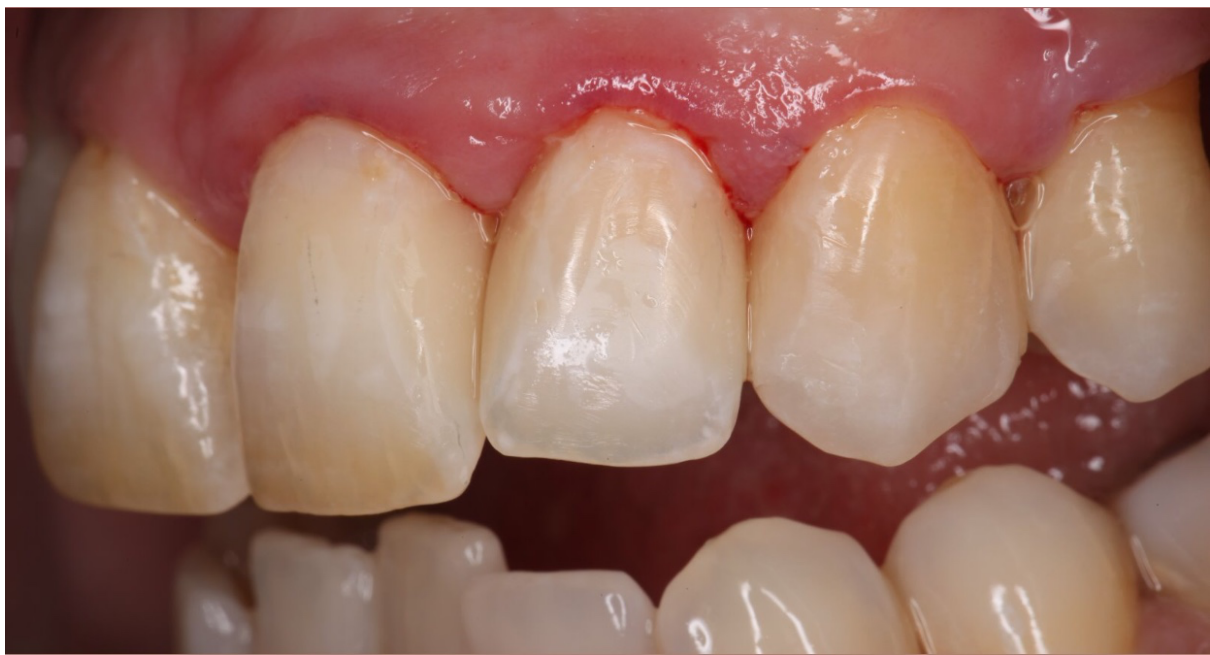
Figure 6 – A different view of the restorations. The patient was delighted with the result as we removed the decay and closed the black triangles.

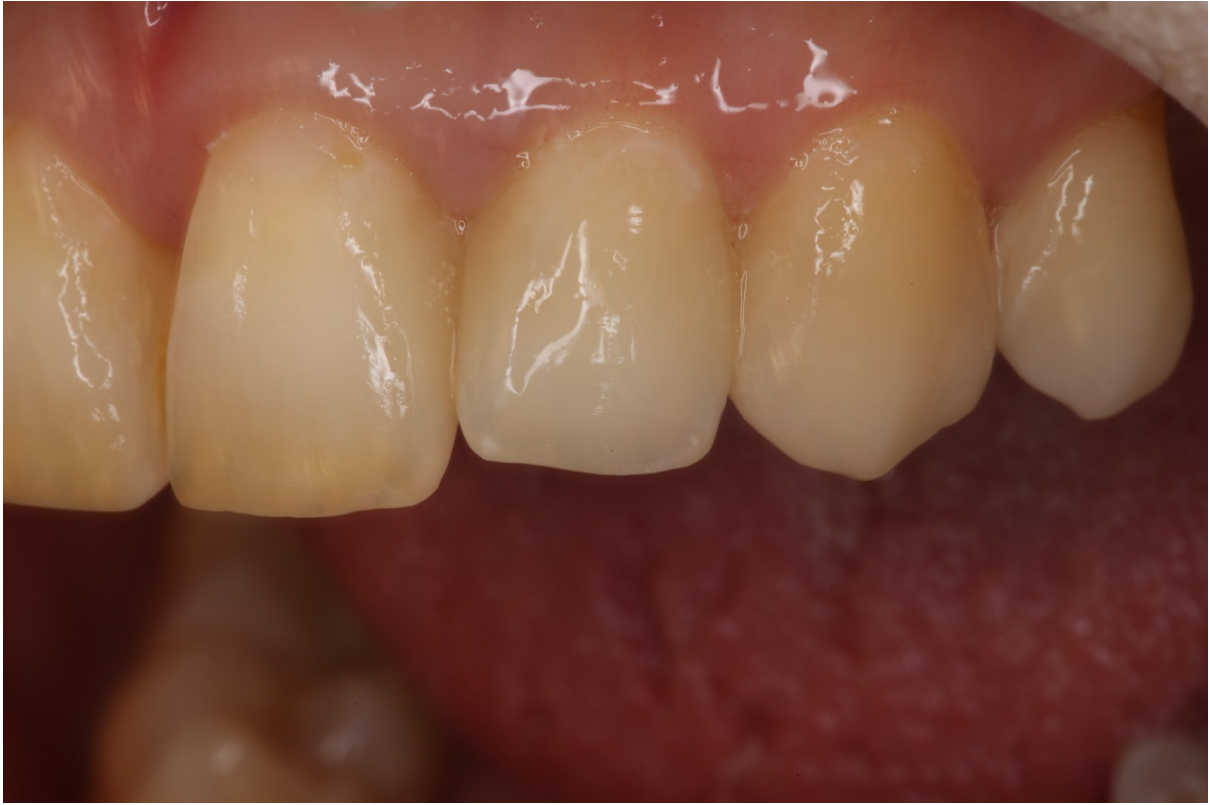
Figure 7 – A one week review of the restorations – the gums have healed and the teeth have rehydrated enabling the restorations to blend in nicely.

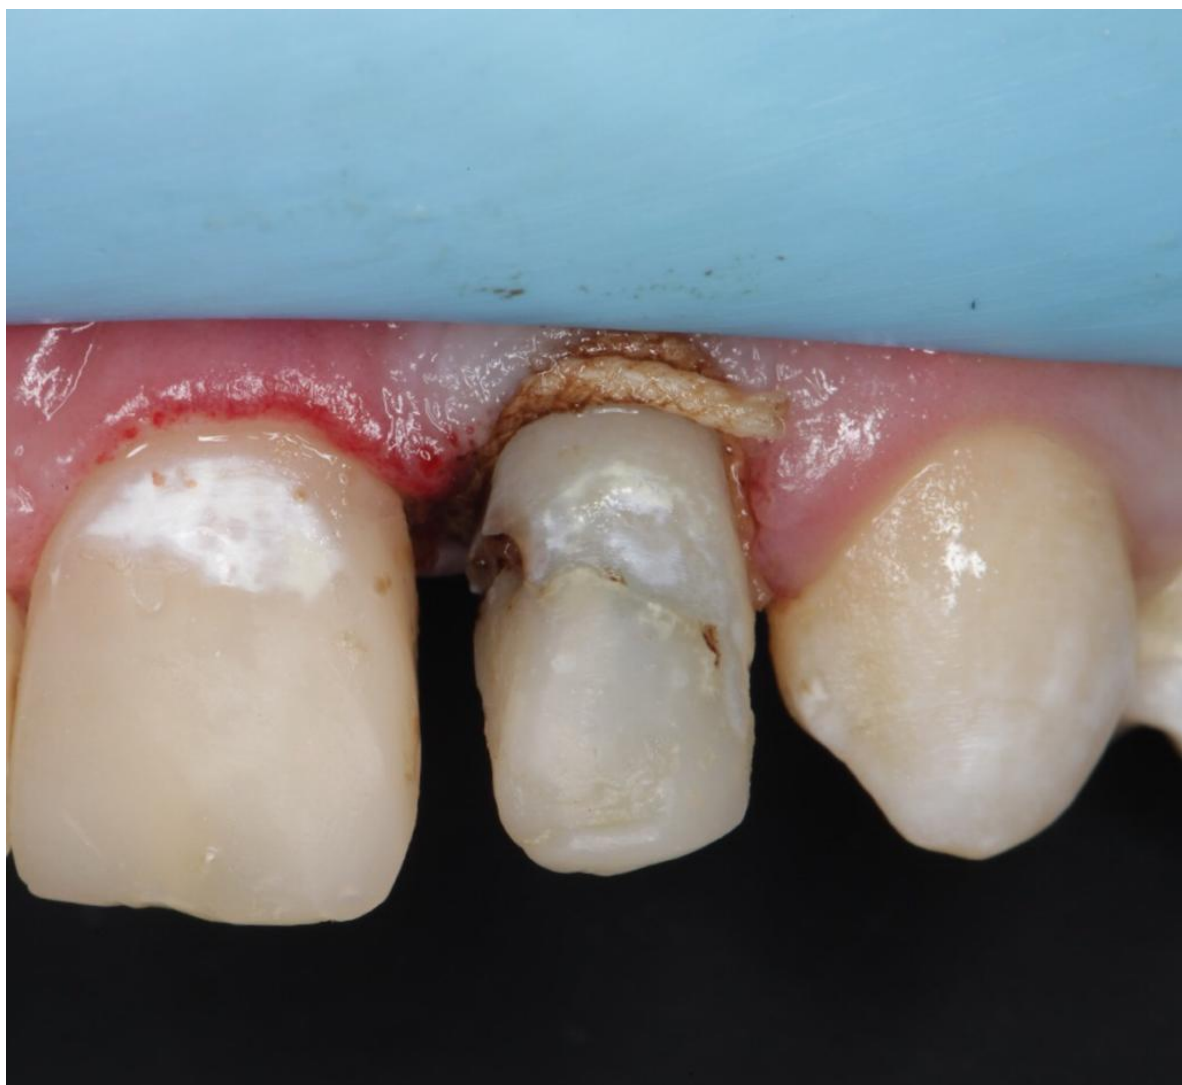
Figure 1 – pre-operative photo showing a carious, discoloured and disproportionate upper lateral incisor. A split dam technique was employed alongside retraction cord to isolate the tooth.

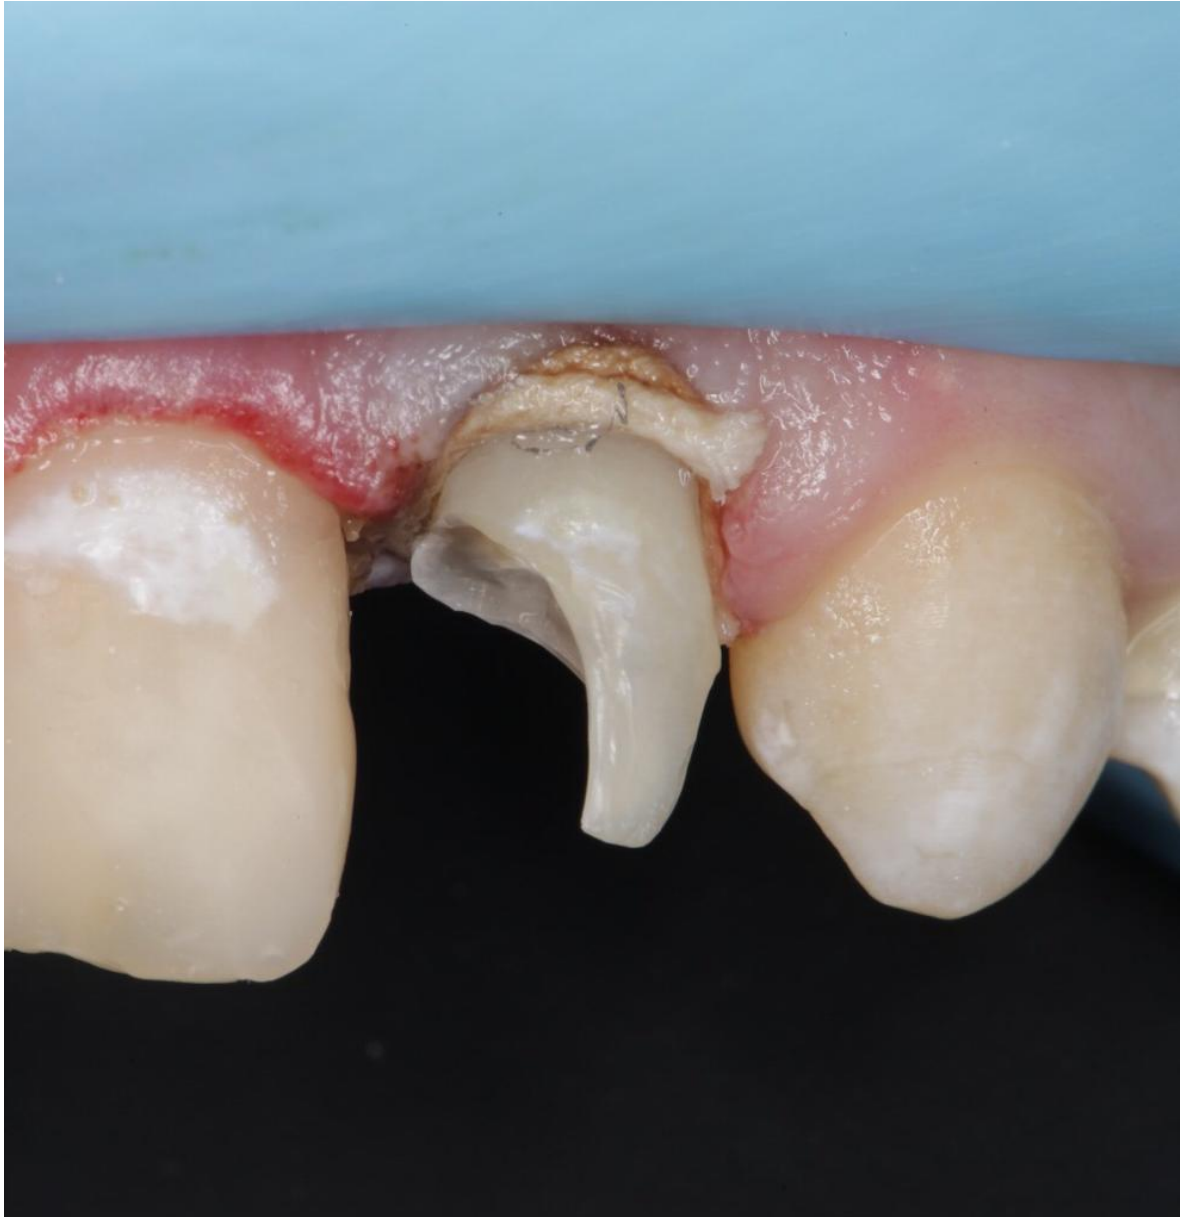
Figure 2 – the old restoration and caries were removed. As there is minimal tooth structure remaining extra care was taken during caries removal and cavity preparation. A caries-free EDJ was achieved, unsupported enamel was removed, and a short bevel was placed on the buccal margin using a medium-grit rugby ball bur (to expose more enamel rods for bonding and to achieve an invisible margin).

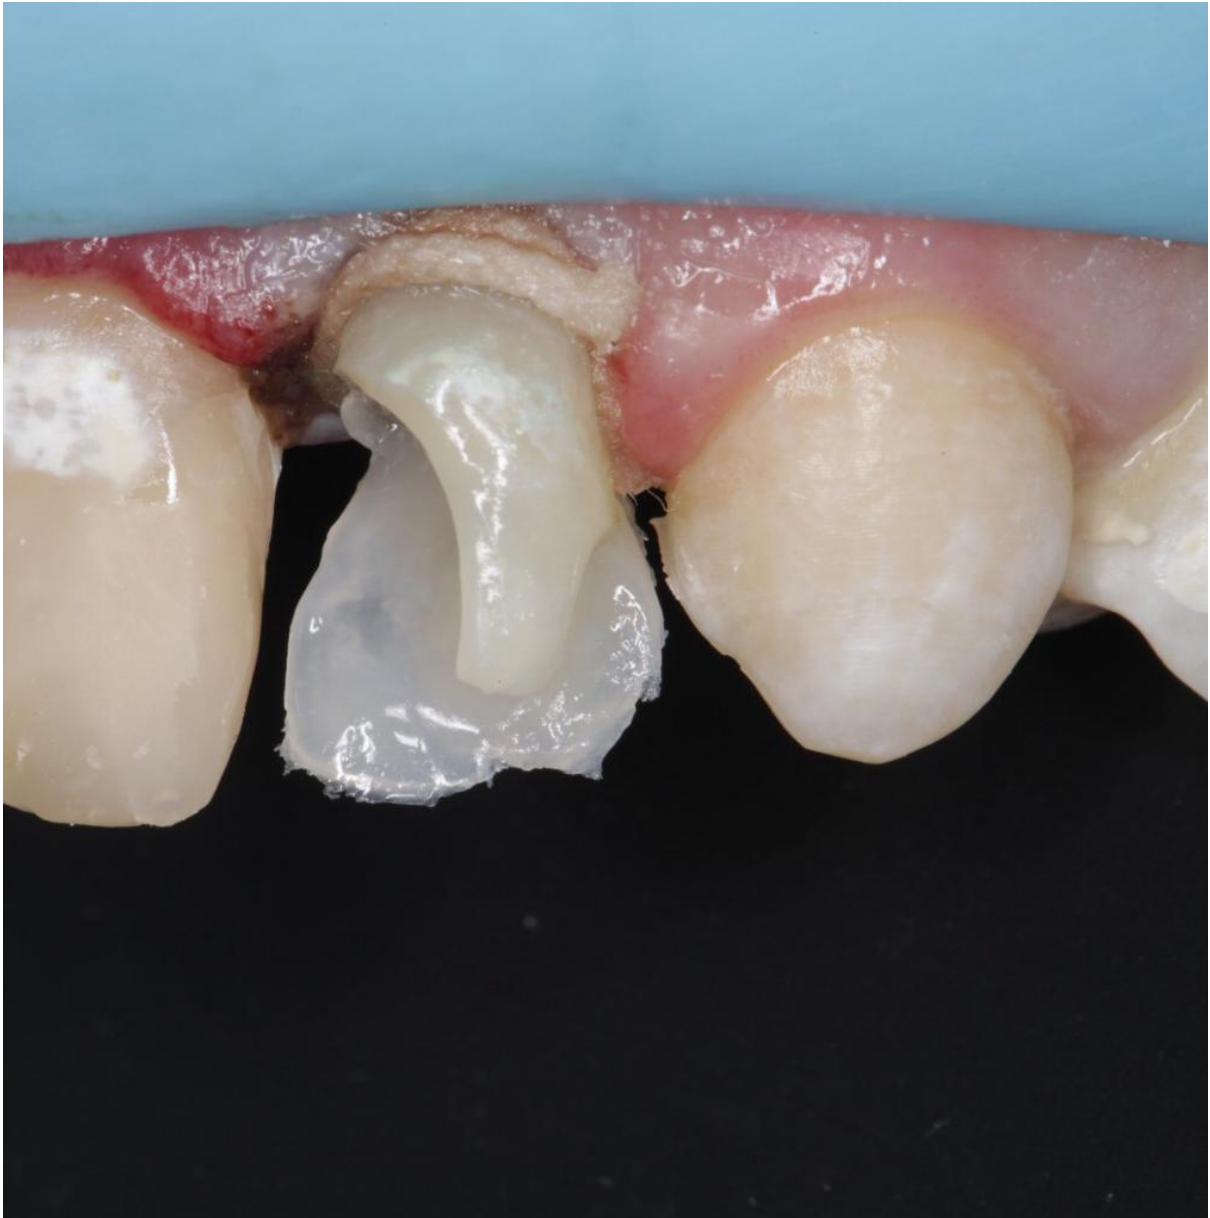
Figure 3 – free hand technique was used to build the new restoration. A mylar strip was placed palatally, enabling a palatal wall to be built. Shade A2 composite (AristoChem)

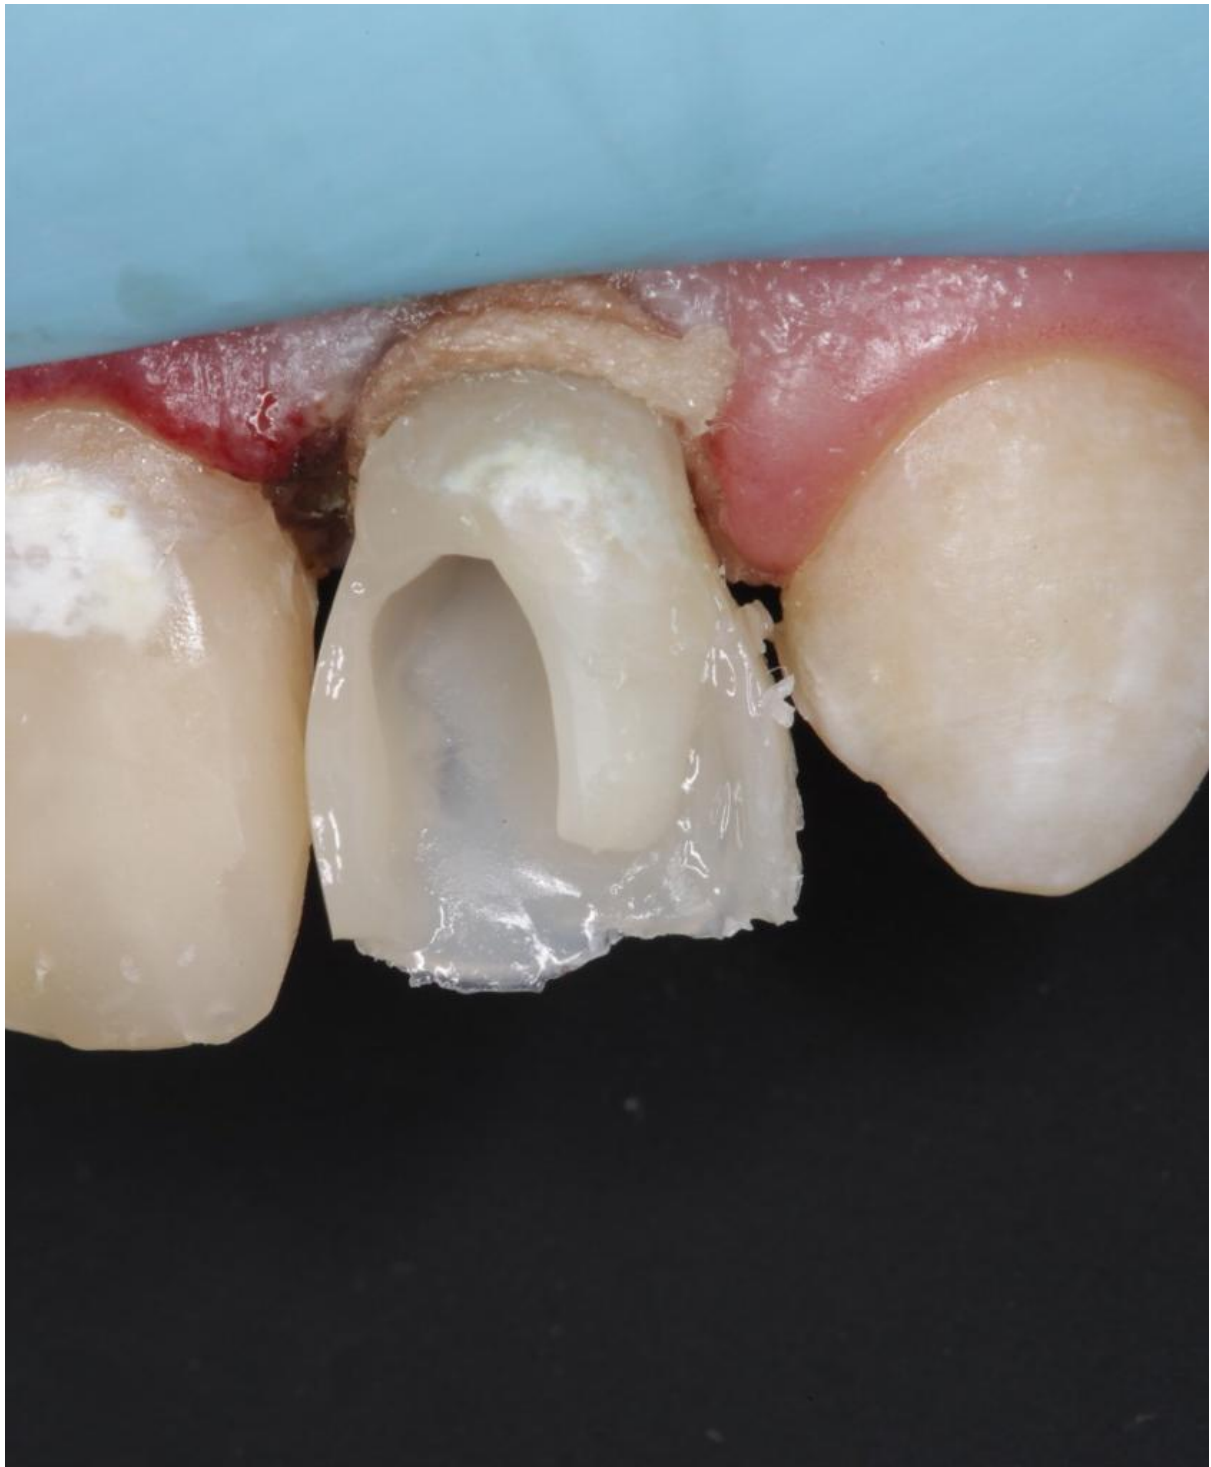
Figure 4 – A tor VM sectional matrix was used to build the proximal walls.

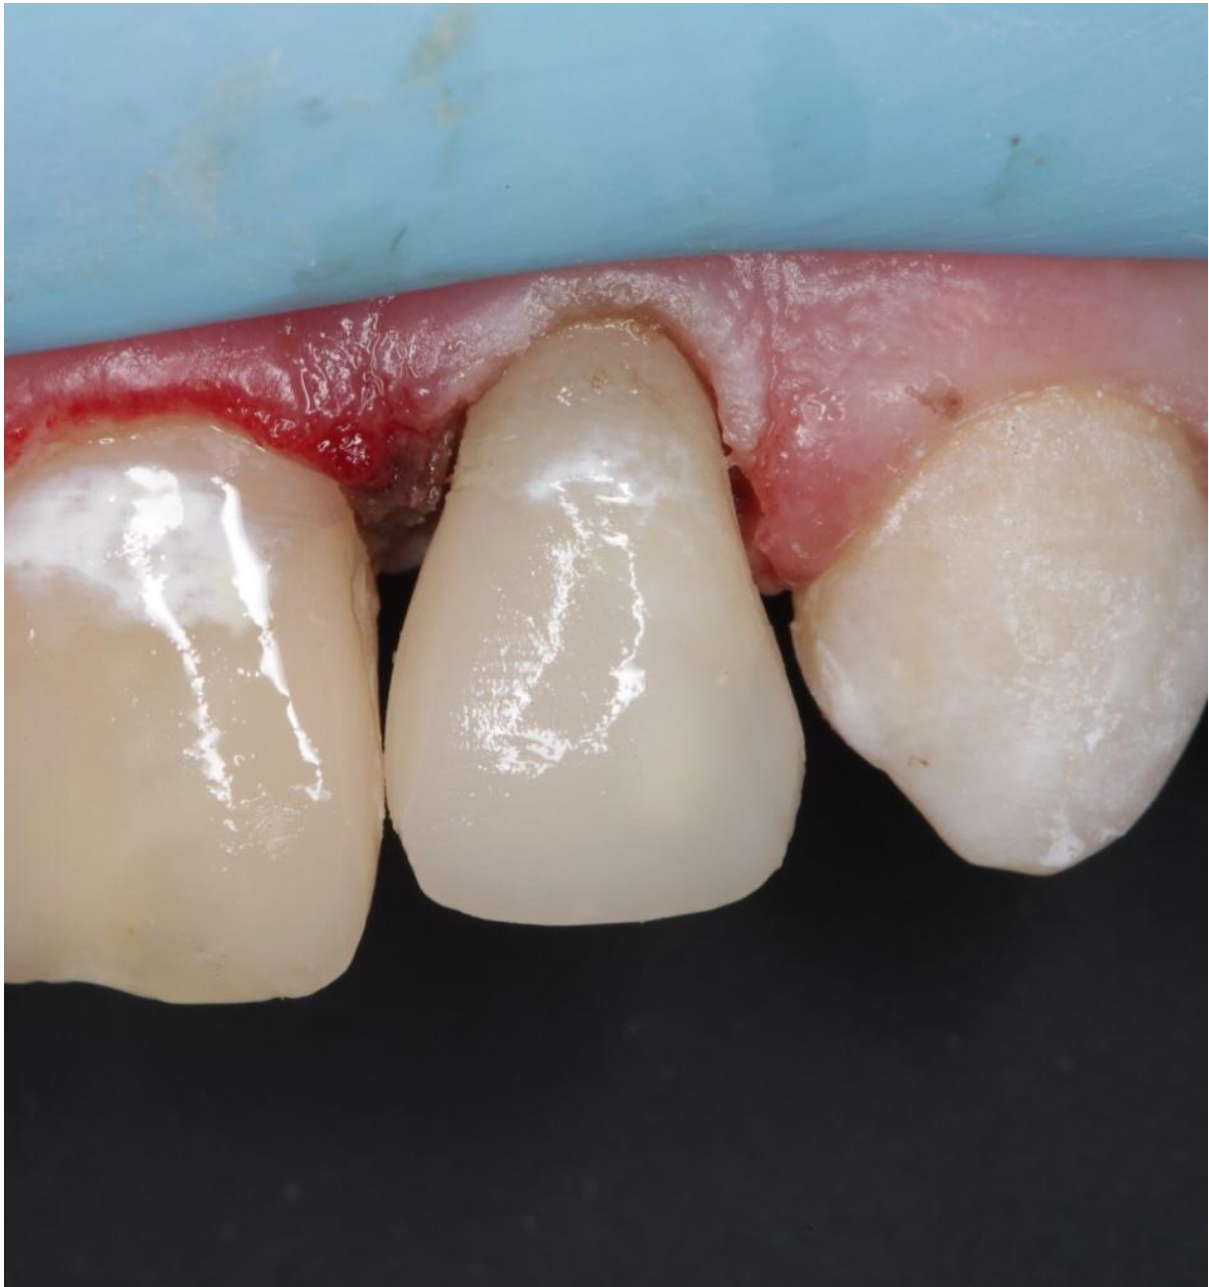
Figure 5 – Composite was placed on the buccal surface and compacted using a micro-brush and flat plastic instrument.

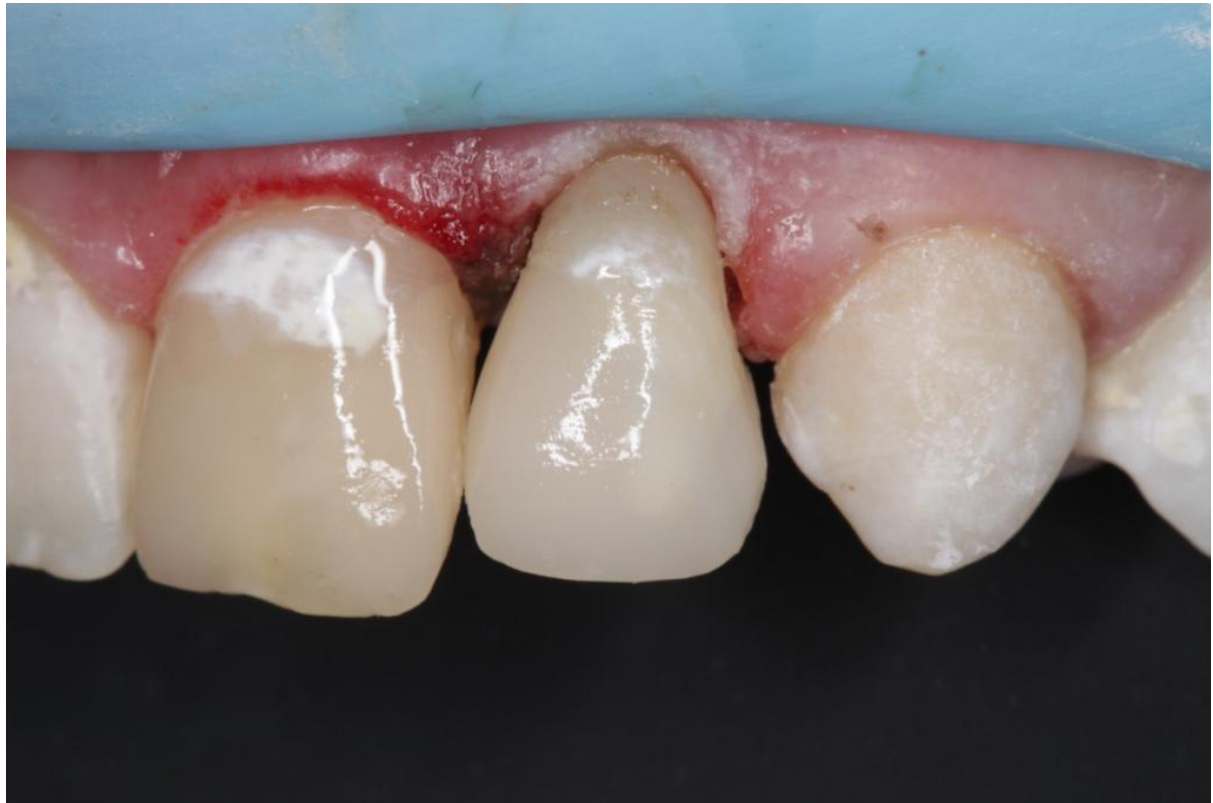
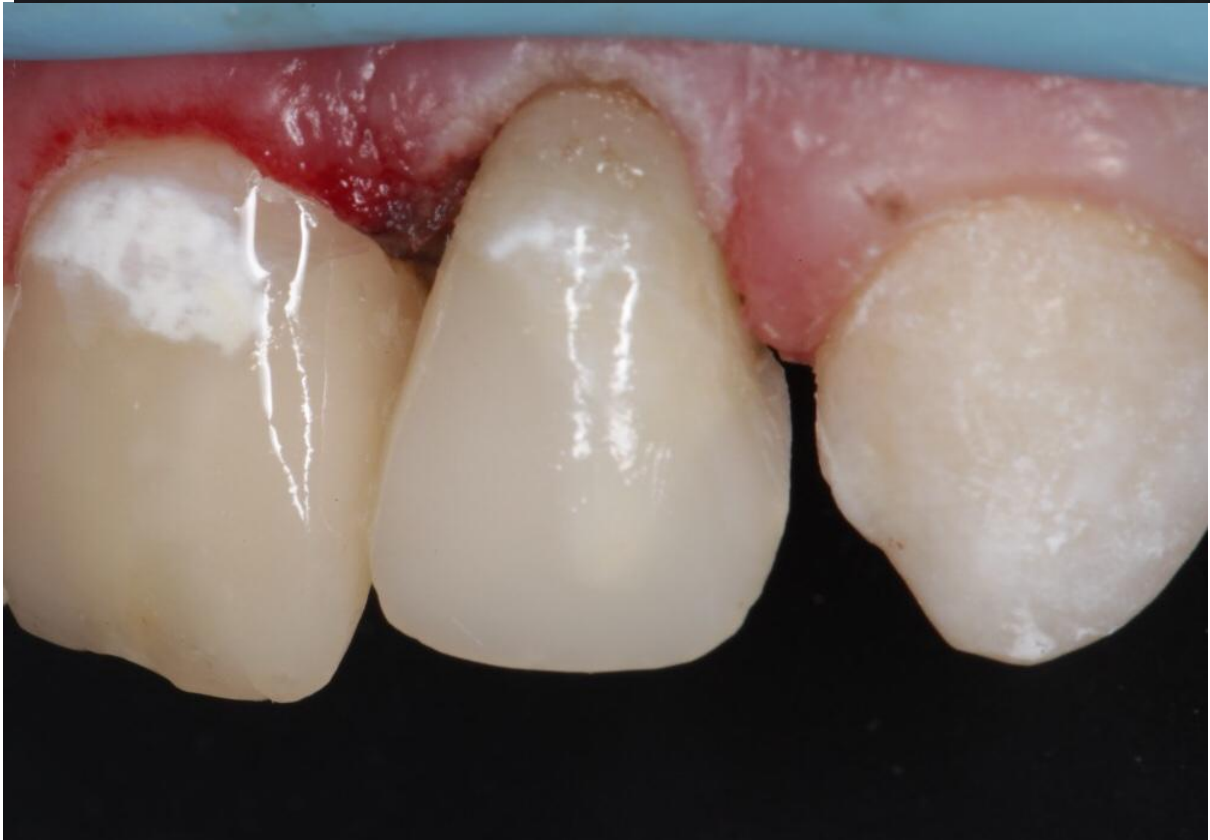
Figure 6 & Figure 7 – Finishing and polishing was completed using a long tapered yellow fine diamond bur, red and orange soft flex discs and the Kerr polishing Occlubrush.

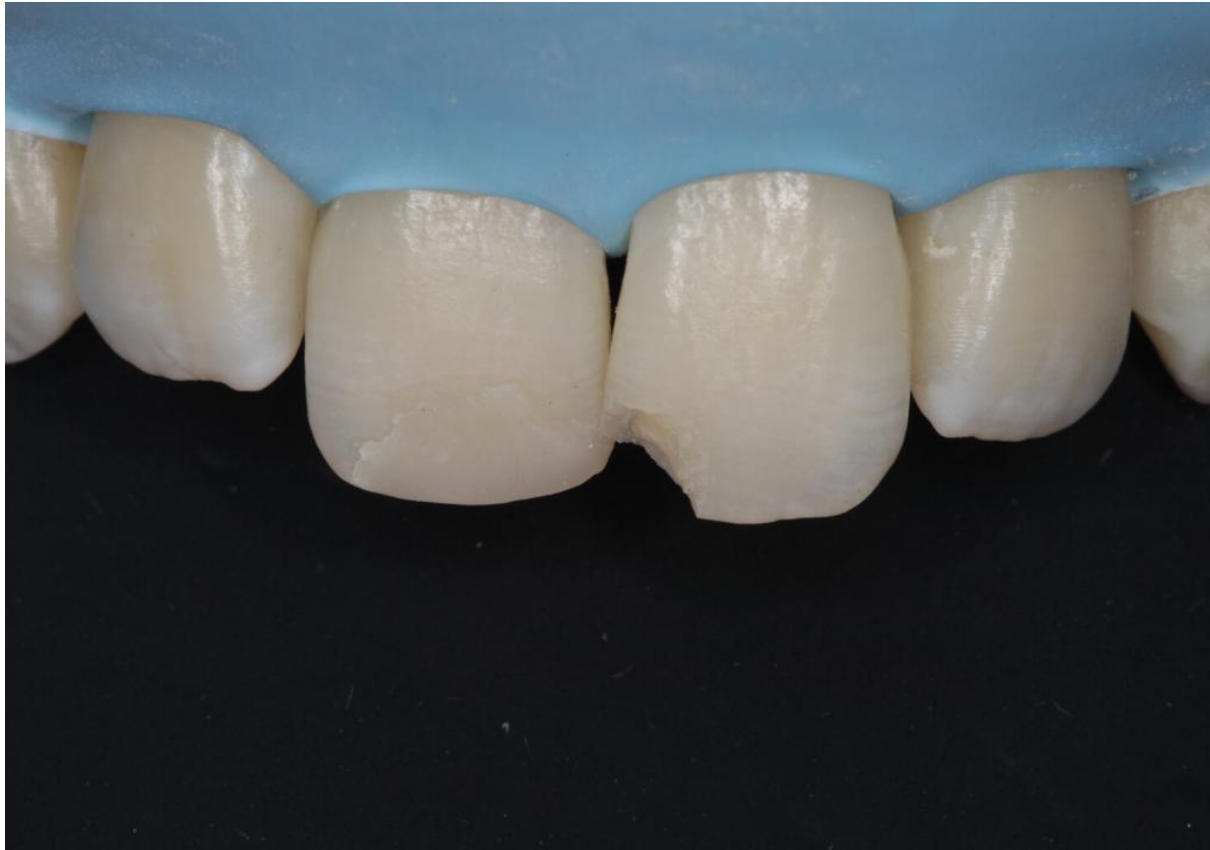
Figure 1 – clamp-less rubber dam isolation canine to canine. Note the incisal overlap resulting in an asymmetrical midline.
