Mini Smile Makeover – Young Maestro Competition

Candidate: Balraj Singh Sohal BDS (Hons)

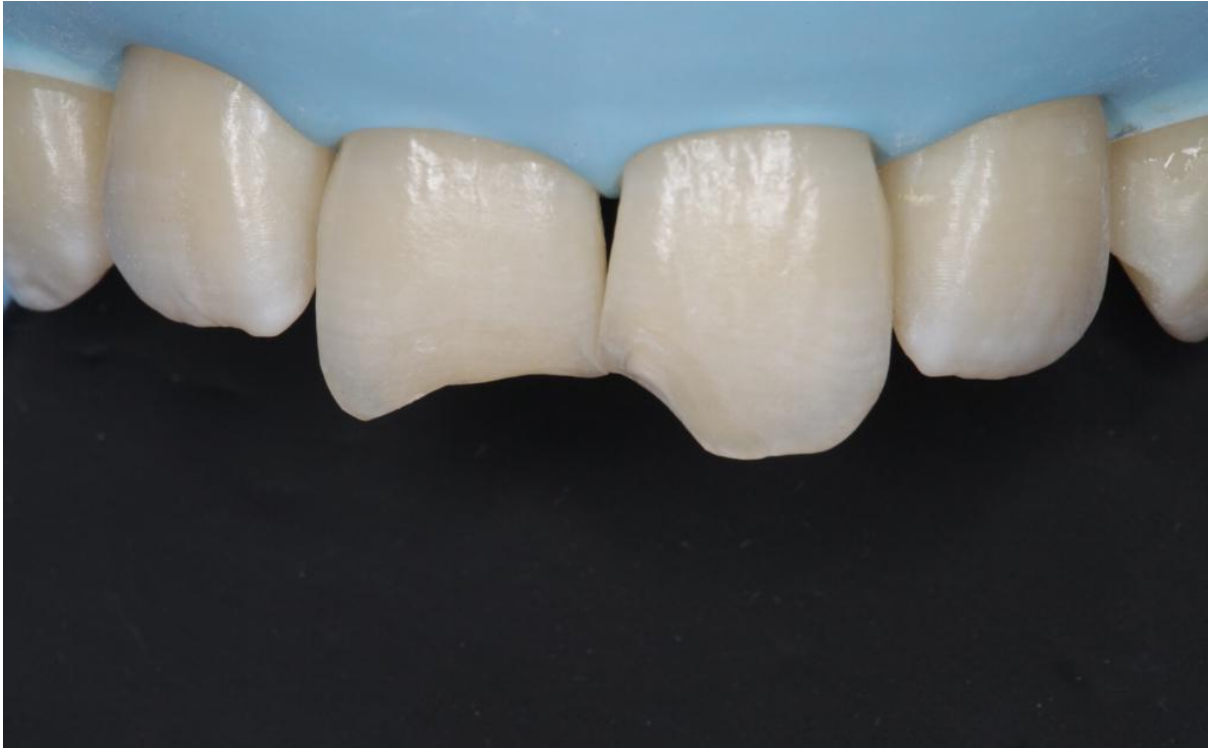
Figure 2 – the old composite restorations were removed; the class IV cavities were bevelled using a long-tapered diamond (red stripe) and soft flex disc to ensure smooth cavity margins. To achieve an aesthetic result (invisible margin) and to expose more enamel rods for a stronger bond a short bevel on the buccal surface was done.

This case was completed free-hand using the mylar strip palatally to build the palatal wall.

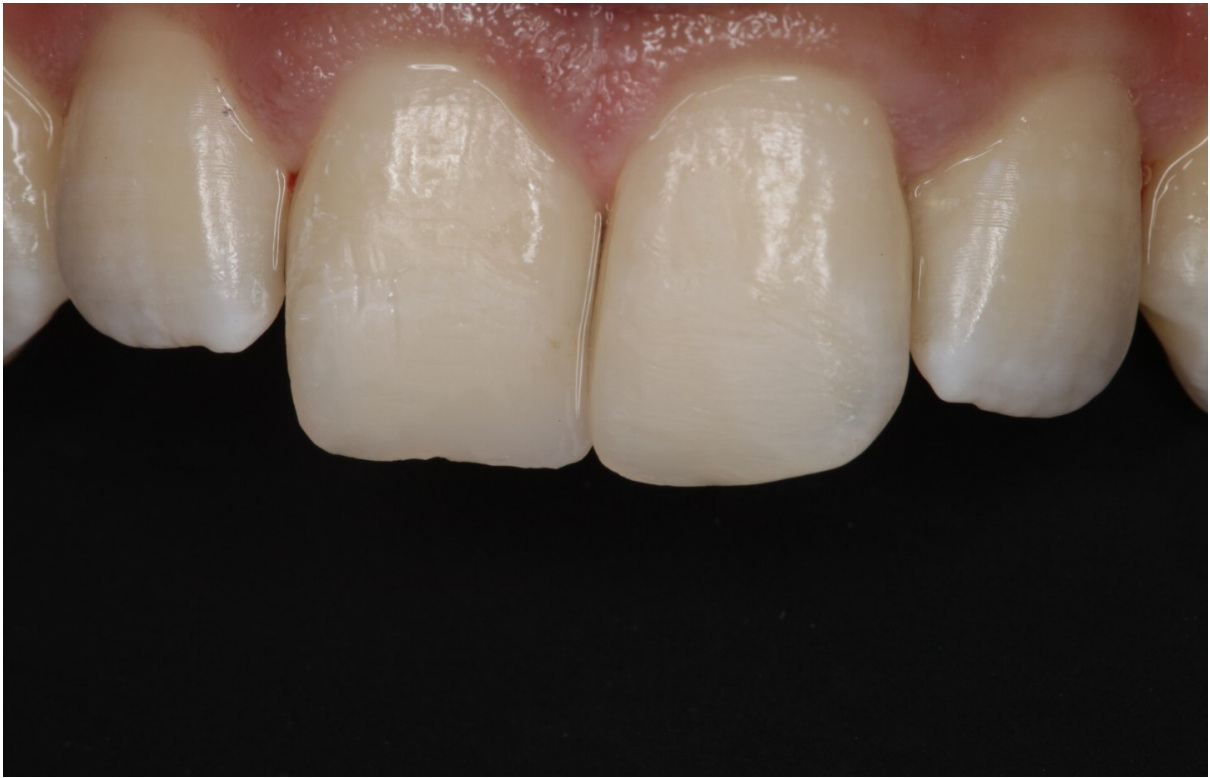
Figure 3 – Immediate post-operative photo, rubber dam removed hence the teeth look dehydrated. Gross finishing and polishing was done using a red soft-flex disc and white polishing fan. The patient was to return 1 week later to have final polishing completed although failed to attend this appointment.
